**SOUHEGAN RIVER WATERSHED  
DAM NO. 26**

**NH 00207**

**PHASE I INSPECTION REPORT  
NATIONAL DAM INSPECTION PROGRAM**

**AUGUST 1979**

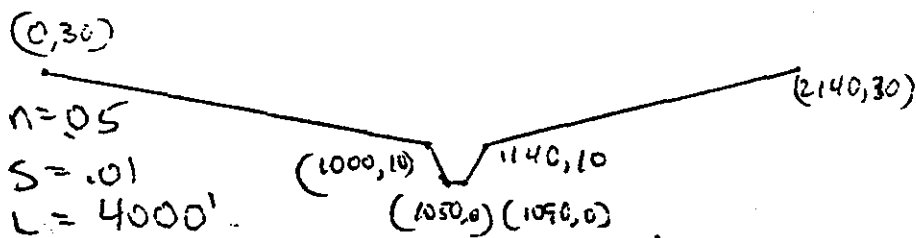
The next damage center is at the Highway 31 bridge across Blood Brook. (The sign on the bridge says Gambol Brook). The following typical cross-section for the 4000 ft. reach to the bridge was established from field notes and U.S. G.S. topo data.

A Stage-Normal Discharge relationship for this reach is given on p. 33. At the pre-failure flow of 7,500 cfs, there would be 9.1 ft. of flow in the channel. The attenuation due to storage in this reach is calculated on D-33.

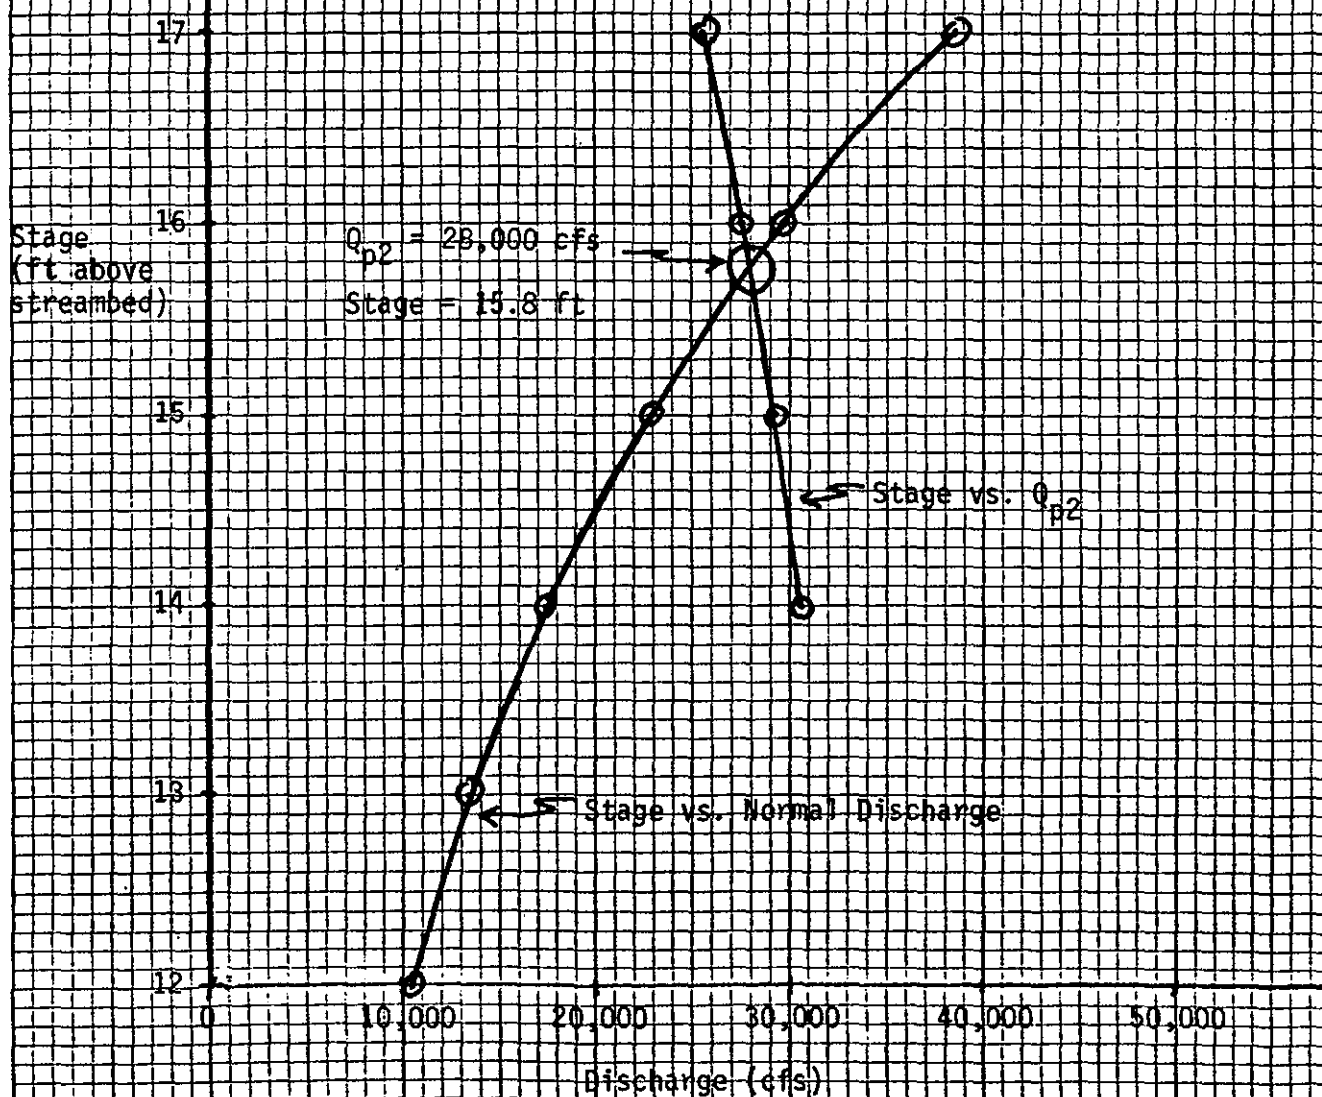
Stage (ft)	Area (above 9.1 ft) (sq ft)	Storage ( $\frac{AREA \times 4000}{43,560}$ ) (ac ft)	$Q_{p2}$ (cfs)
14	1482	136	30,600
15	2072	190	29,200
16	2762	254	27,600
17	3552	376	25,700

The attenuated peak failure flow at the Highway 31 Bridge would be 28,000 cfs, which would create a stage of 15.8 ft. in Blood Brook.

The Highway 31 Bridge has a low chord about 15' above the stream, and would probably not be seriously damaged by this flow. A junkyard about 15 ft. above the stream bed and 3 houses 20 ft. up are probably also above serious flooding.
